# Keynes Controls Ltd

Ref : Firmware Upgrade - NDACS 6000 system

The following instructions describe the actions to be followed to complete an upgrade from NDACS system firmware 3209 -- 3221 to the latest firmware release date 11 Sept 2002 version 3553.

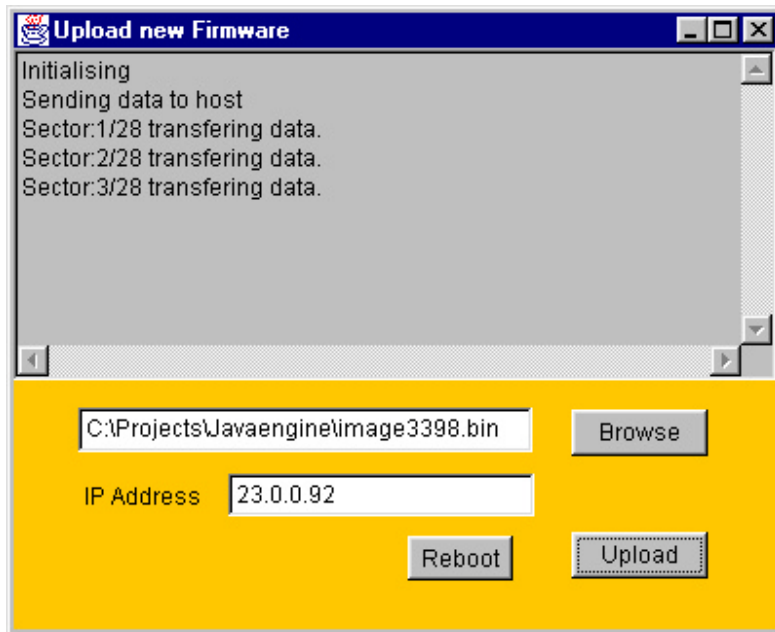
1) Activate the flashloader software and the Window shown below should appear

2) Enter IP address of the instrument to be upgraded into the box provided.

The example shows the software uploading new firmware into an instrument with IP address 23.0.0.92
